Extended Abstract : Proposals for the integrated conservation of three Middle Byzantine Period churches and their neighborhoods in Istanbul

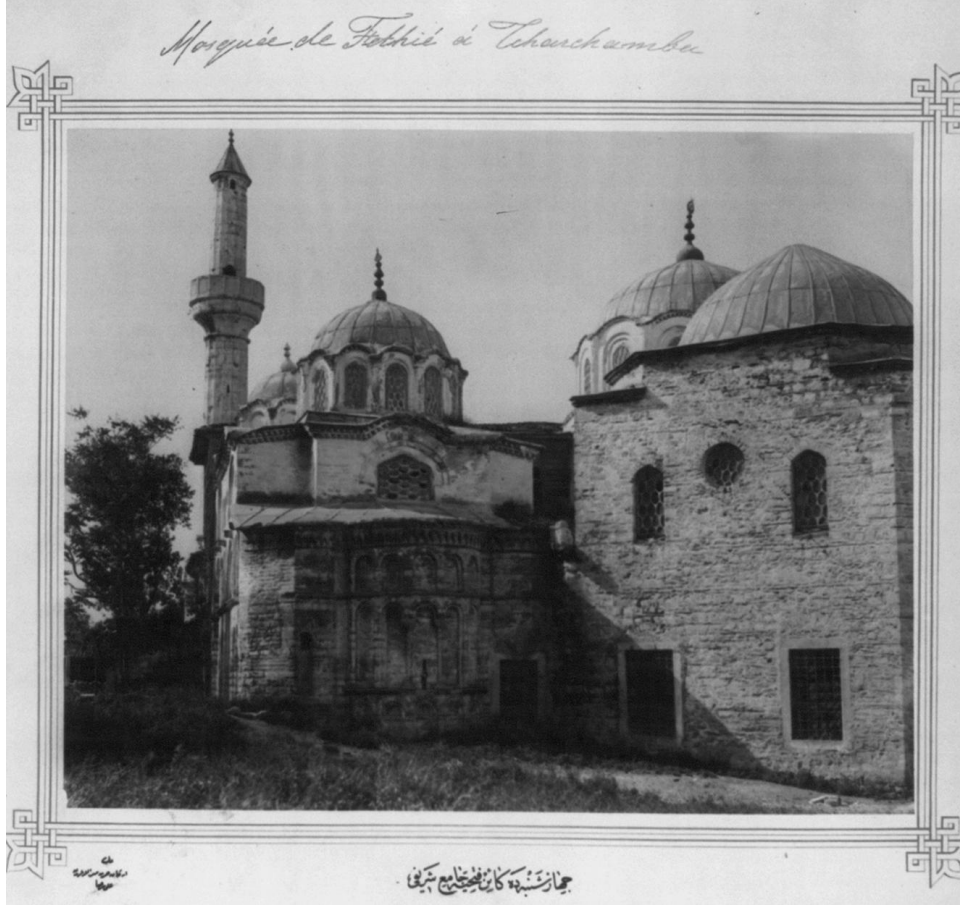
-Figure 2 : Fethiye Camii at Tscharchamba, Abdulhamit Archives (around 1890's).

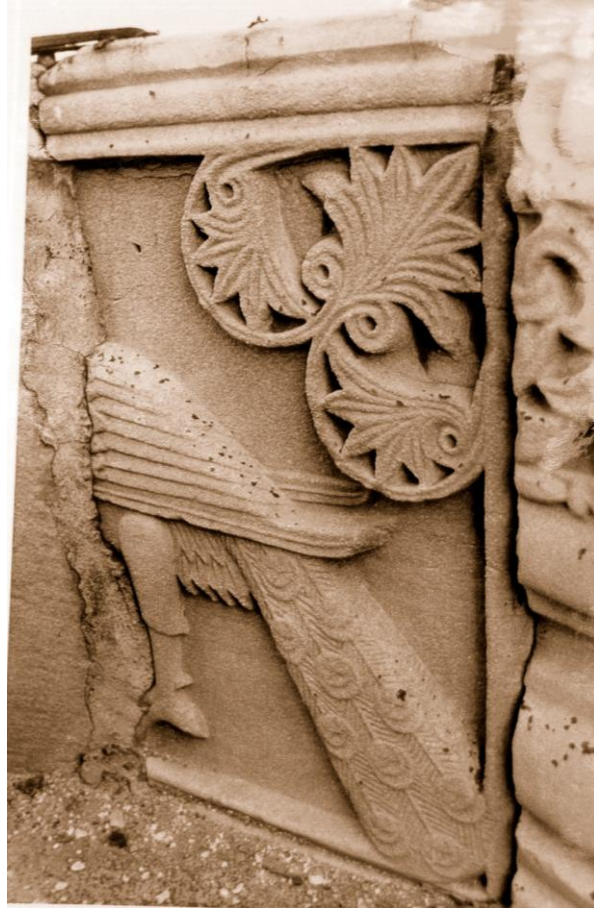
-Figure 3: Parapet slab dating back to seventh century A.D. It disappeared from the minaret balcony of Kilise Camii after 1995 (Erdoğan, plate:502).

My summer fellowship at Dumbarton Oaks Library and Fieldwork Archives in 2008 provided me with some very important photographs from the field works and surveys. They have been of great help in making comparisons while writing my detailed descriptions. Since recent interventions have wiped out many key traces on the buildings, such archival photographs present more information than the current conditions of the buildings. By examining previous photographs from archives or dissertations in detail, it was possible to discover great losses such as the parapet slabs dating back to seventh century A.D (Fig. 3). They disappeared from the minaret balcony of Kilise Camii sometime after 1995 when they could have been photographed in-situ probably for a last time by Erdoğan².
